**DEPARTMENT OF TRANSPORTATION**

Contract #: 04-0120F4Cty: SF/ALA Rte: 80 PM: 13.2/13.9File #: 69.28**WELDING INSPECTION REPORT****Resident Engineer:**Pursell, Gary**Address:** 333 Burma Road**City:** Oakland, CA 94607**Report No:** WIR-001448**Date Inspected:** 13-Feb-2008**Project Name:** SAS Superstructure**OSM Arrival Time:** 1830**Prime Contractor:** American Bridge/Fluor Enterprises, a JV**OSM Departure Time:** 730**Contractor:** Zhenhua Port Machinery Company, Ltd (ZPMC), Changxing Island **Location:** Shanghai, China

Caltrans Quality Assurance (QA) Inspector, Mike Hasler was present to observe the fitup, welding and related activities associated with the fabricating of Caltrans Mock-up, 77M, 89M, 114M and U-Rib Trial Assembly, for the San Francisco Oakland Bay Self Anchored Suspension Bridge, at Zhenhua Port Machinery Company (ZPMC) facility on Changxing Island.

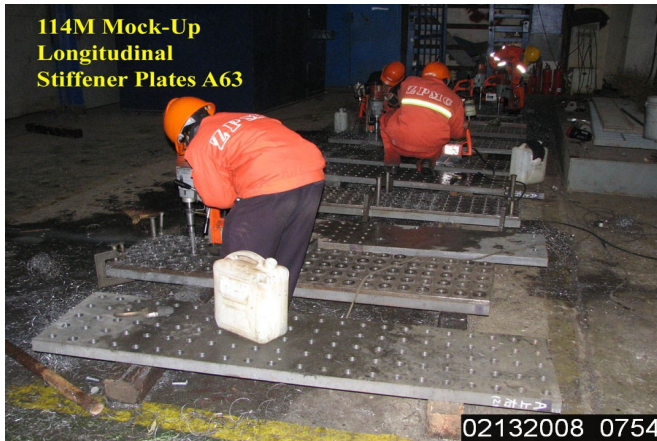
Item Description	WBS	Dwg No.	Status
1 Interior Longitudinal Stiffener Plates	NA	NA	Work In Progress

114M (upper tower shaft) Mock-up: Caltrans QA Inspector observed ZPMC shop workers drilling interior longitudinal stiffener connection plates. The connection plates were identified as A63. ZPMC workers were observed match drilling the connection plate using a magnetic drill with an annular drill bit. The drilling of the connection plates appeared to be in general conformance with the Tower Splice Mock-up Fabrication Procedure. Following digital picture illustrates the drilling in progress at the work station.

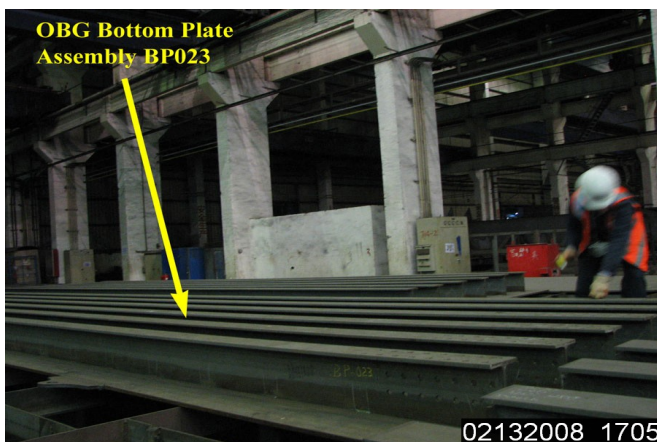
- 2 Bottom Plate Assembly NA NA NA

OBG: Caltrans QA Inspector observed tack welds on bottom plate (BP023) assembly in Bay 3. The assembly is approximately 15180 millimeters long with six split tees tack welded to the plate. The tees will be joined to the bottom plate, full length, 10 mm (millimeter) fillet weld, both sides. Caltrans QA Inspector observed that the tack welds joining the tees to the bottom plate appeared to be in general conformance with the project requirements. The following digital picture illustrates the bottom plate assembly.
